Case report

Oxidized zirconium on ceramic; Catastrophic coupling

V.E. Ozden^{a,*}, N. Saglam^b, G. Dikmen^a, I.R. Tozun^a

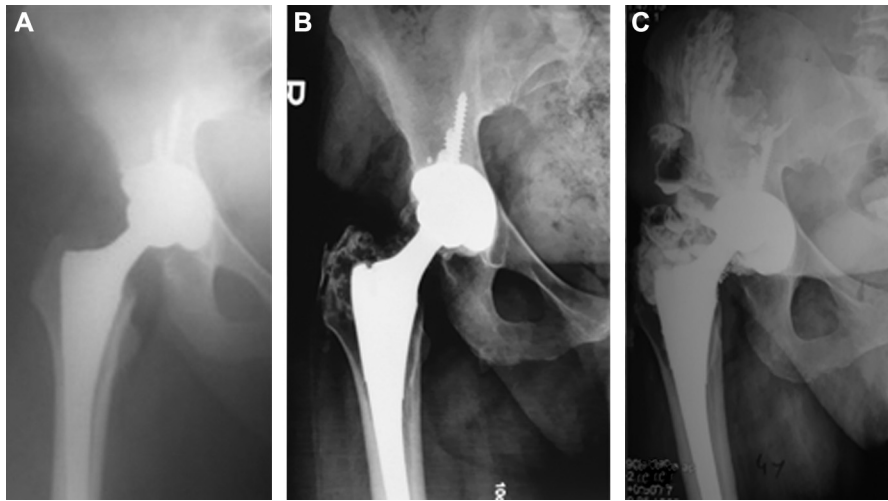
Revision of right hip prosthesis was planned due to her complaints, clinical examinations and radiographies (Fig. 1). During her revision, there were synovia colored black, stained heavily with metallosis that radiated proximally through intermuscular interval along the gluteus maximus and medius muscles. Forty-six millimeters cementless, porous coated, hemispheric ceramic Reflection[®] InterFit acetabular component (Smith & Nephew, Memphis, TN, USA) along with an alumina ceramic liner (BioloX[®] Forte; CeramTec, Plochingen, Germany) had been used. Ceramic liner was found broken at its corner and +12 mm 28 mm OxiniumTM (Smith & Nephew, Memphis, TN, USA) head had severe deformation (Fig. 2). The femoral component was found stable. All tissues with metallosis were debrided. The cup and the head were revised with 56 mm ceramic Reflection[®] InterFit acetabular component (Smith & Nephew, Memphis, TN, USA) along with an alumina ceramic liner and 36 mm ceramic head (BioloX[®] Forte; CeramTec, Plochingen, Germany). Histological examination showed wear debris granulo-mas with histiocytic reaction and fibrosis.

Fig. 1. Plain radiographs showing a 52-year-old female patient who underwent right hip arthroplasty. A. Immediate postoperative after the index operation. B. At her fourth year's follow-up showed early metal debris collection in joint and around greater trochanteric area. C. At 4 year 4 months' follow-up taken in our clinic showed metallosis radiates to proximally through gluteal muscles. Eccentric position of the head in the cup was also observed.

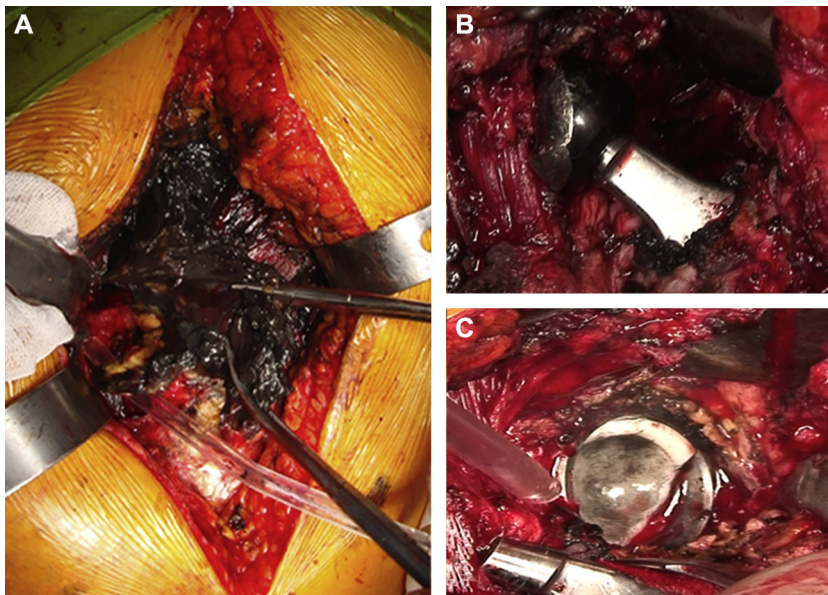
Fig. 2. A. Dark stained metallosis on trochanteric area and distal insertion of gluteus medius muscle. B. Deformed Oxinium™ head. C. Broken ceramic liner. There was no visible corrosion or signs of fretting on femoral head taper.

Recently, accelerated wear of OxZr head without a trauma or dislocation has been reported in one case. After 10 years, there had been accelerated wear, with femoral and acetabular bone changes as a result of OxZr head and ultrahigh-molecular-weight polyethylene wear during a 6-month period [12]. In our three cases, the deformation of the heads was observed on patients' third, fourth and seventh years of index operations, respectively. Dark stained metallosis radiated proximally, distally and even medially into the bony acetabulum. We did not observe any bony destruction on both acetabular and femoral sides. There were no visible corrosion or signs of fretting observed on femoral tapers (Fig. 2). All femoral components were stable. Histologically, two of our cases showed

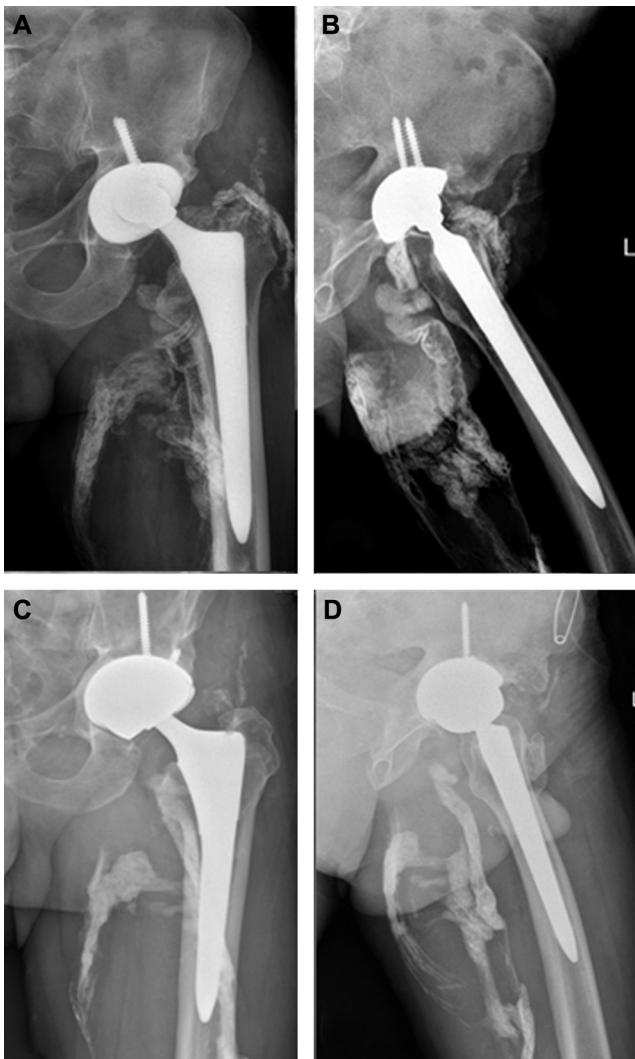
Revision of left hip arthroplasty was performed due to his radiographs and clinical complaints. Metallosis with dark black colored synovia was observed around the trochanteric bursa and distally through posterior compartment as expected from his preoperative radiographies (Fig. 3). Eccentric positioned 32 mm Oxinium™

Fig. 3. A 64-year-old male who underwent left hip arthroplasty at his third year's follow-up. Anterior posterior (A) and lateral (B) radiographies showed metallosis radiating distally through posterior compartment and eccentric position of the head. The radiographies at 4 years' follow-up after MOM revision: anterior posterior (C) and lateral (D) view.

head was found deformed and the articular surface of alumina ceramic liner (Bilox® Forte; CeramTec, Plochingen, Germany) was covered with dark metallic color (Fig. 4). The acetabular component was 54 mm cementless, porous coated, hemispheric ceramic Reflection® InterFit (Smith & Nephew, Memphis, TN, USA) and found to be well fixed to the bone. It was extracted with an extractor and revised with R3® Stiktite coated acetabular component with metal insert. Femoral component was found stable. The 48 mm BirminghamHR® (BHR, Smith & Nephew Inc., Memphis, TN, USA) metal head with +12 mm metal sleeve had to be used to restore the offset (Fig. 3).

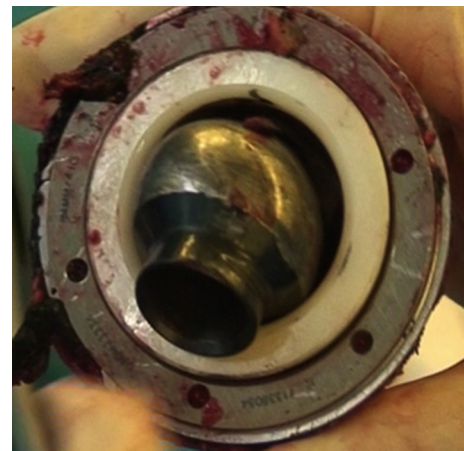
Fig. 4. Extracted cementless, porous coated, hemispheric ceramic Reflection® InterFit component after 3 years from index operation with alumina Biolox® Forte ceramic liner and deformed Oxinium™ head.

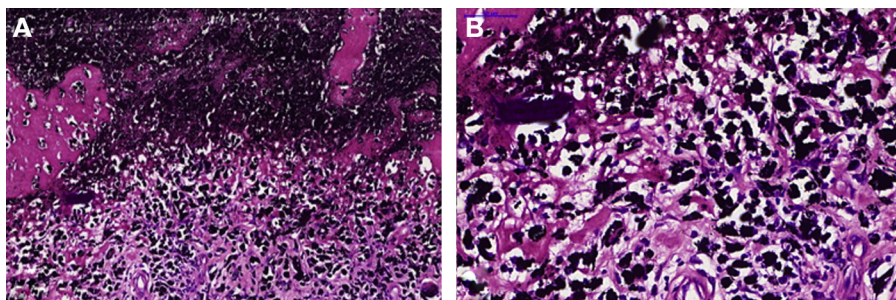
Histology revealed soft-tissue granulomas of the wear debris with generalized histiocytic reaction and fibrinosis with granular amorphous necrotic material (Fig. 5).

Fig. 5. Histology (in Case 2) revealed soft-tissue wear debris granulomas with generalized histiocytic reaction and granular amorphous necrotic material with fibrinosis. A. 67× H&E. B. 350× H&E.

same wear debris granulomas with histiocytic reaction without necrosis as reported by Tribe et al. [5]. However, a coagulation necrosis in one of our cases was observed in addition to this (Fig. 5). Acetabular component revision was performed in order to change bearing couple. Different bearing couples were used in each revision case. Restoration of the length and the offset with available components in our hands affected our choice for bearings. Now, we have concerns about the complications related to use of the metal on metal and the ceramic on ceramic couples in revisions [13,14]. Clinical and radiographic evaluations were performed at six weeks, three and six months, and one year after surgery and then annually. None of the patients has any problem at their last follow-ups.

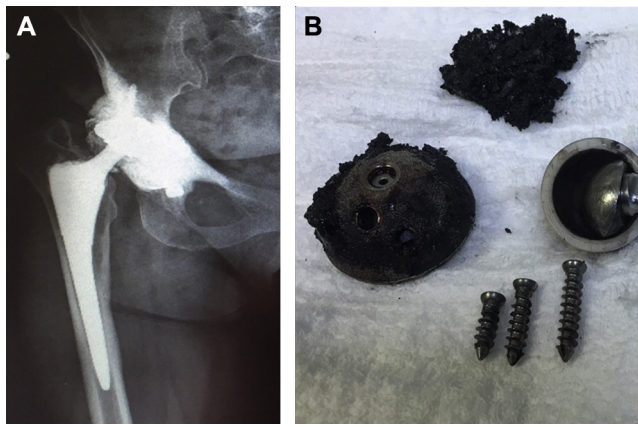
revealed significant metallosis that infiltrated into bone, especially around the acetabular cup (Fig. 6).

Fig. 6. A 55-year-old female who underwent right total hip arthroplasty seven years ago complained of left hip squeaking for four months. A. At seventh years' AP radiography showing metallosis around cup. B. During revision; extracted cup, ceramic liner and debris bony material.

Revision of right hip arthroplasty was performed according to her complaints and radiographies. There was dark colored metallosis that covered the synovia of the joint. A 48 mm cementless, porous coated, hemispheric ceramic Reflection® InterFit (Smith & Nephew, Memphis, TN, USA) acetabular component was extracted without an extractor. Metallosis was observed also around the bone of the extracted cup (Fig. 6). The remaining bony acetabulum was stained with dark metallic color but seemed well nourished with the bloody appearance. A 50 mm Reflection® InterFit cementless component with highly cross-linked polyethylene liner was implanted. The femoral stem was found stable. A +16 mm 32 mm OxZr femoral head had to be used to restore the offset and the length leg discrepancy.
